# Reno/Virginia Peak (KRGX) Dome Failure

19 December 2008  
Approx. 1030 UTC

National Weather Service  
Reno, NV

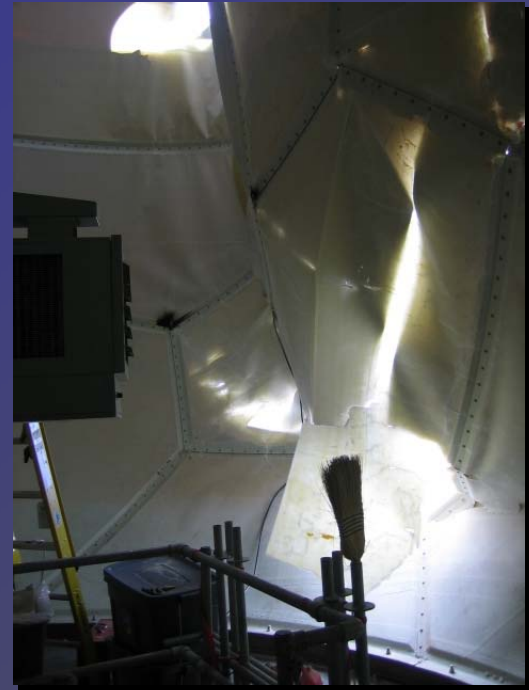
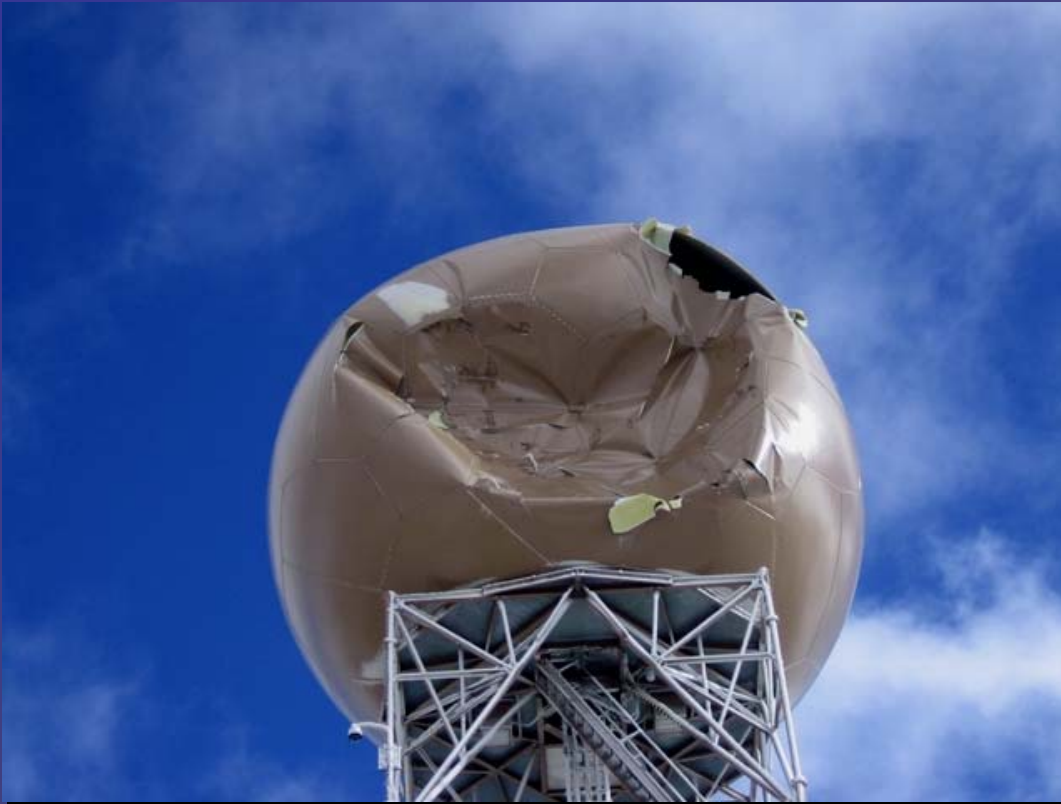
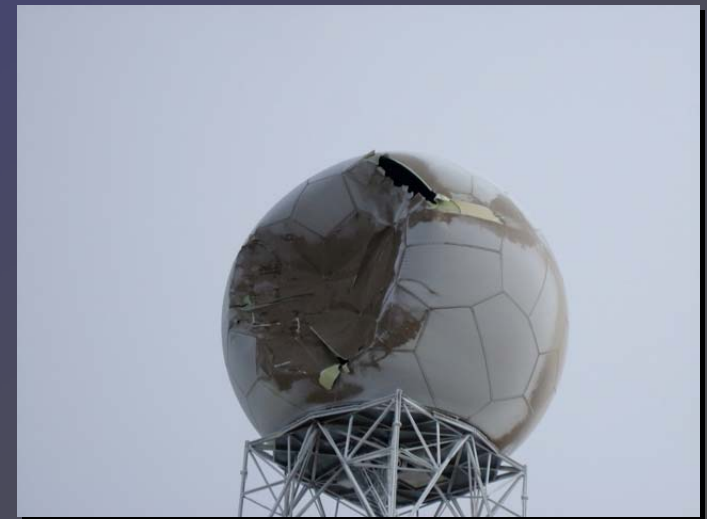
Photos taken by NWS Reno electronics team, on first visit to radar after dome failure (19 Dec.).

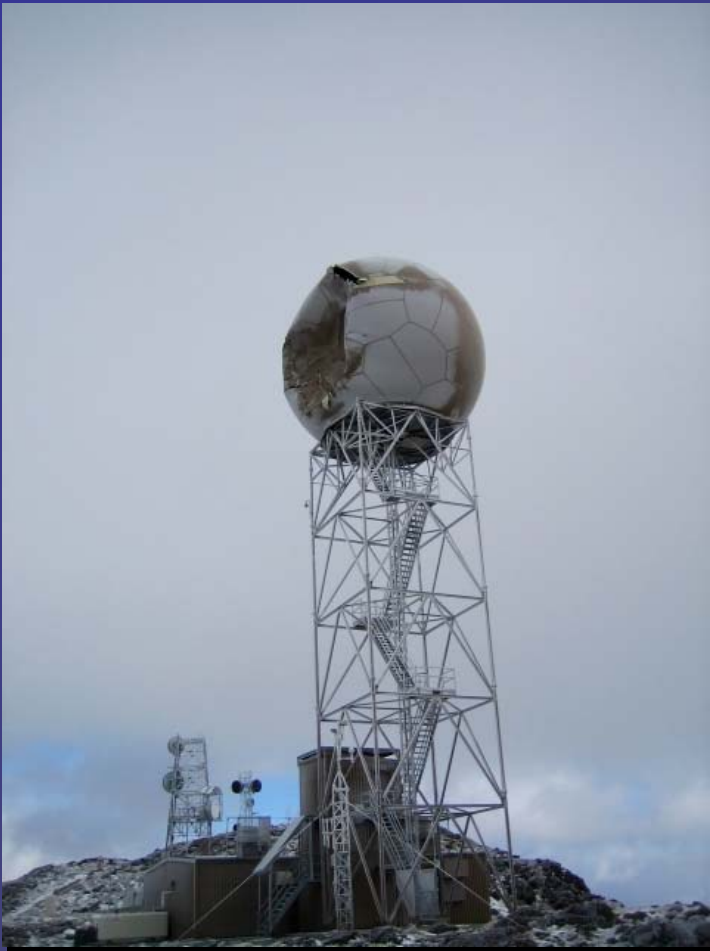
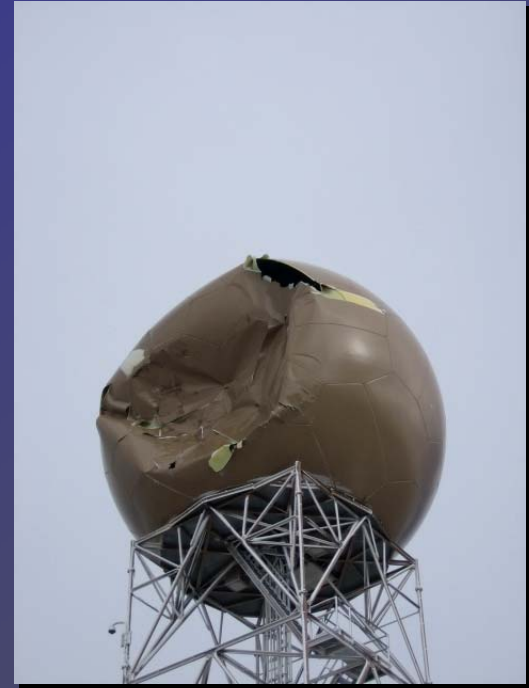
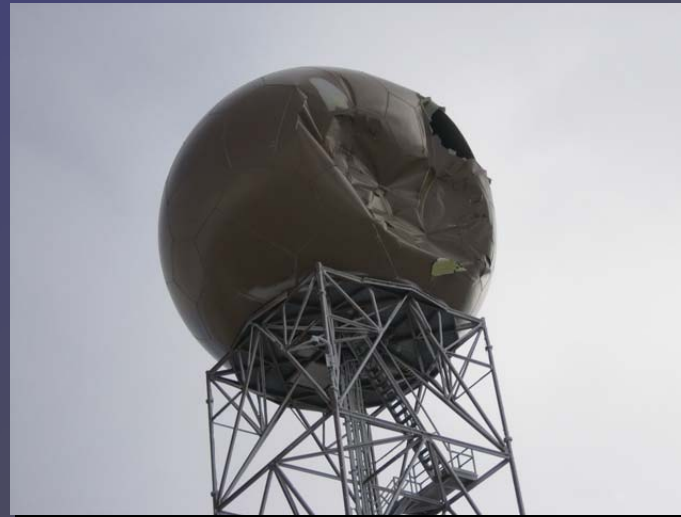
Photos taken by NWS Reno electronics team, on first visit to radar after dome failure (19 Dec.).

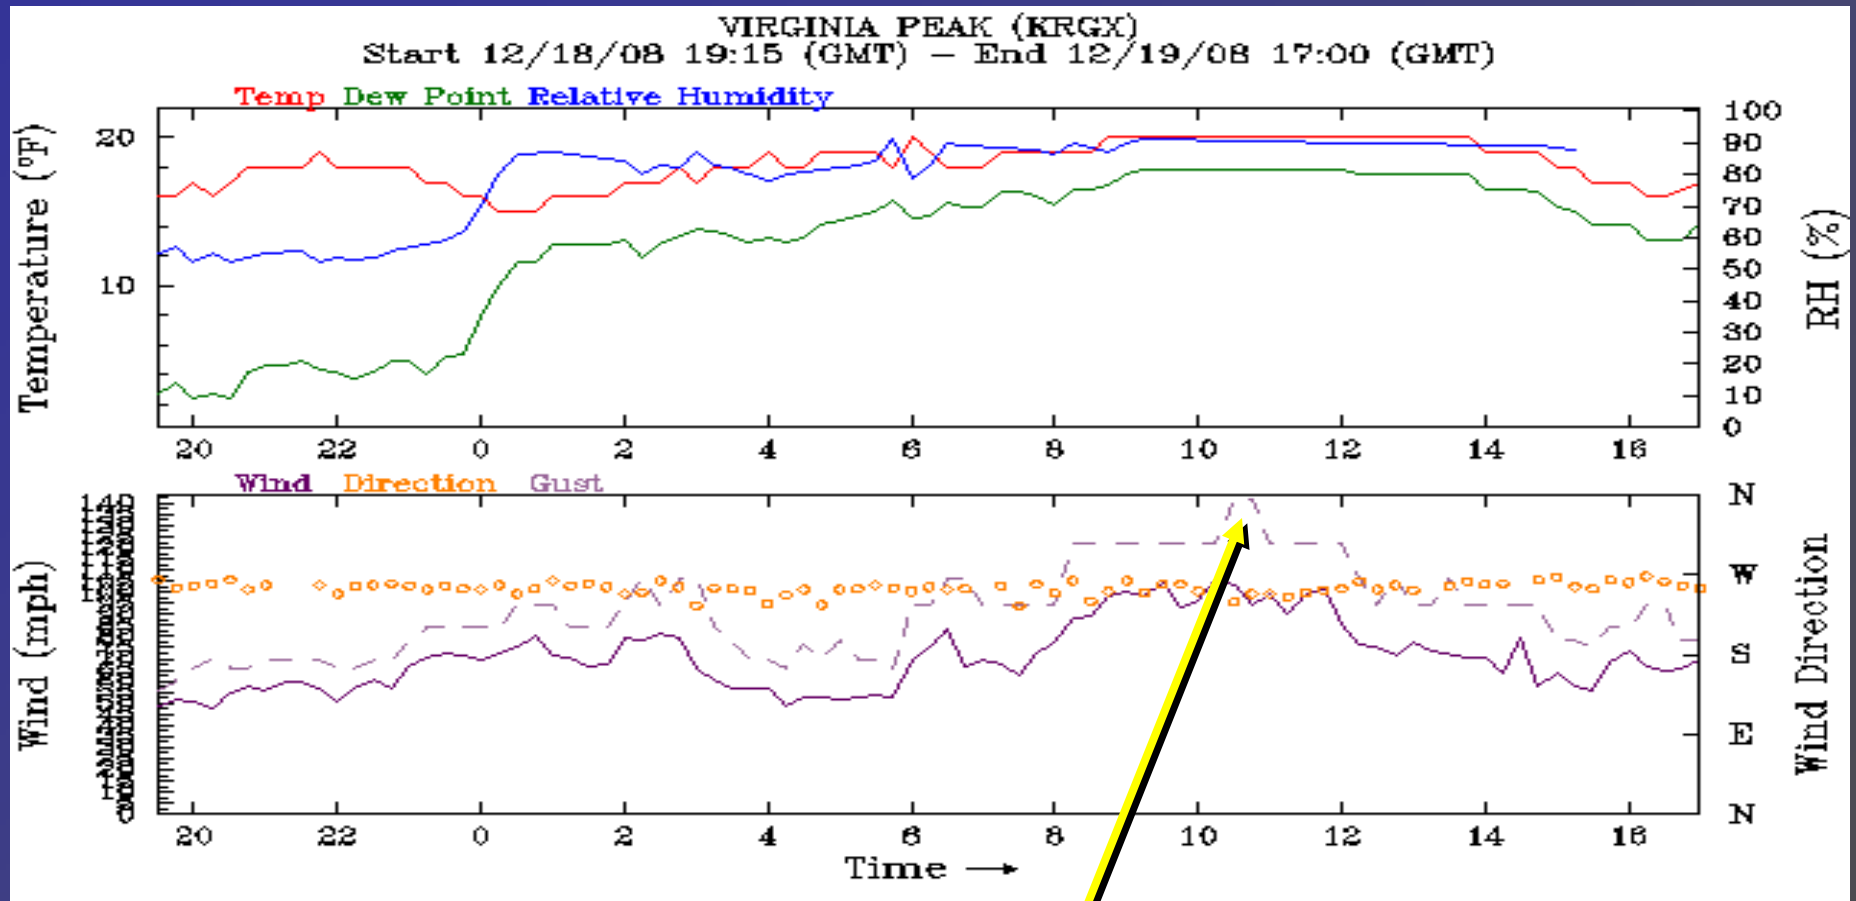
# Virginia Peak Weather Data

Elevation: 8299 ft MSL

140 mph peak gust occurred at the same time the radar failed.
